SCM PRO UPDATE ANNOUNCEMENT CRITICAL SOFTWARE UPDATE FOR SCM PRO MODULES USED IN FIELDPILOT PRO AND UNIPILOT PRO SYSTEMS

The SCM Pro is the primary controller module used in all FieldPilot Pro and UniPilot Pro systems.

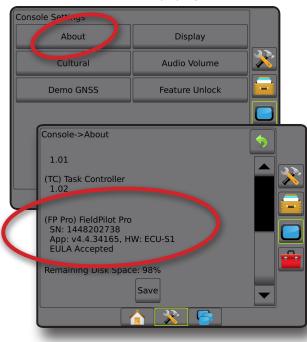
- 1. Press SYSTEM SETUP bottom tab
- 2. Press CONSOLE side tab
- 3. Press About.
- 4. View the 'App:' (software version) for the device '(FP Pro) FieldPilot Pro'
- 5. Press RETURN arrow 5 or CONSOLE side tab 🔲 to return to the main Console Settings screen.
- NOTE: The Save option is not available for selection (grayed out) until a USB drive is inserted properly.
